JOINT HIGHWAY RESEARCH PROJECT

FHWA/IN/JHRP-80/4

Final Report

MAINTENANCE METHODS  
FOR CONTINUOUSLY REINFORCED  
CONCRETE PAVEMENTS

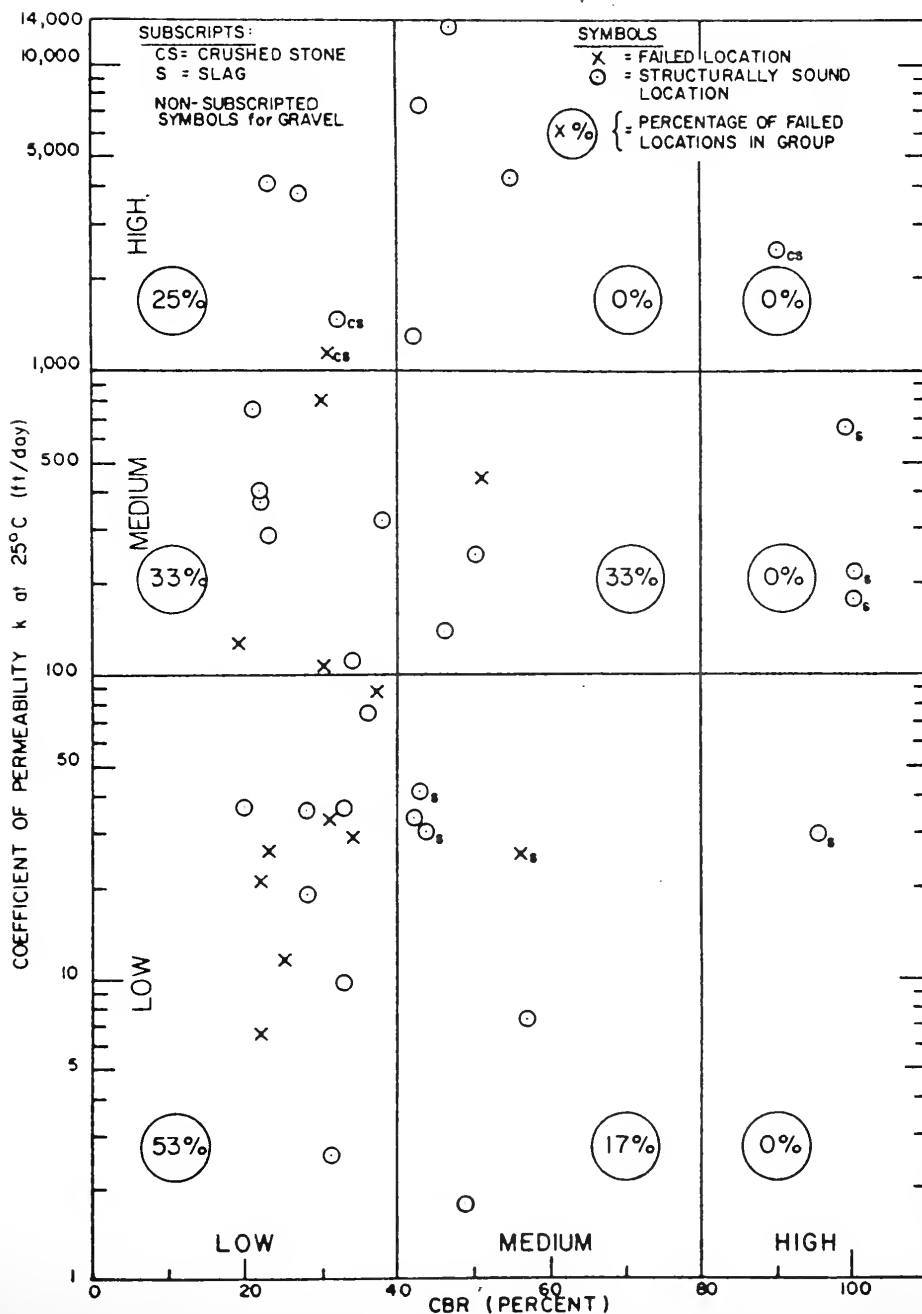
FIG.1. EFFECT OF SUBBASE STRENGTH AND PERMEABILITY ON CRCP PERFORMANCE (FROM FAIZ, REF. 23).

It is worthwhile to note that concrete pavement performance is also a function of the interaction between subbase permeability and strength (CBR). In Figure 1, the estimated field permeability values are plotted against field subbase CBR values measured at the shoulder-slab interface. These values pertain to 46 test locations of the detailed field study. Test data for crushed stone and slag subbases are shown with separate indicators. In addition, values obtained at failed-test locations are differentiated from the values at good-test locations. The data were grouped in nine categories corresponding to three levels each of subbase CBR and permeability. For low subbase strength (CBR < 40 percent), mainly gravel subbases, the percentage of failed test locations decreased from 53 percent in the low permeability group ( $k < 100$  ft/day) to 25 percent in the high permeability group ( $k > 1000$  ft/day). For medium subbase strength (40 percent < CBR < 80 percent), no failures were observed where permeability was greater than 1000 ft/day. Where subbase strength (CBR > 80 percent) was high (applies only to slag and crushed stone subbases) no failures were indicated irrespective of permeability.

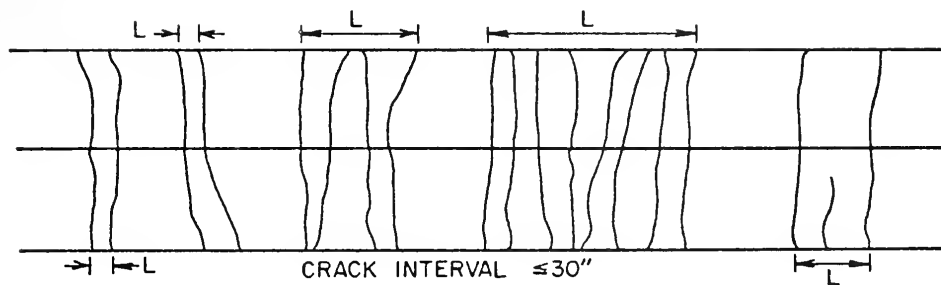
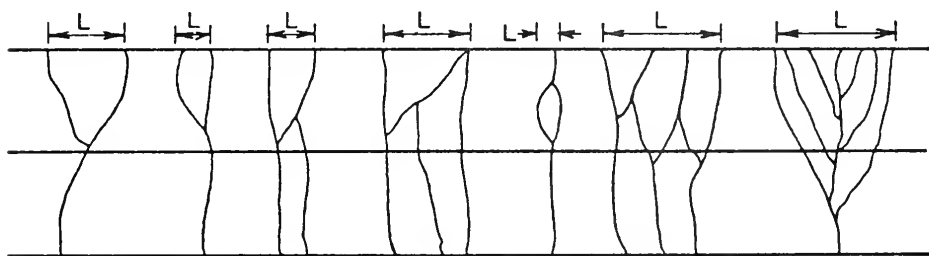
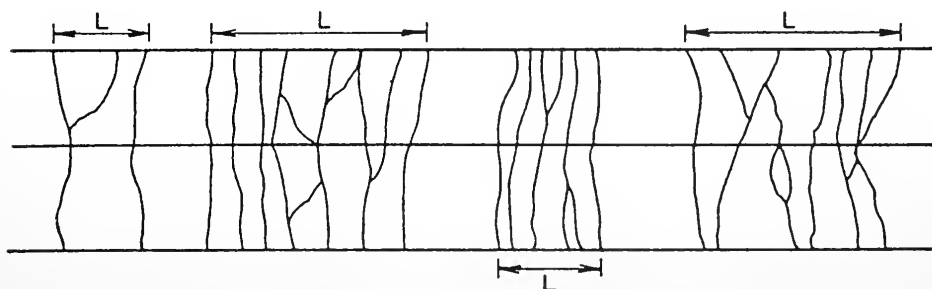
## PARALLEL CRACKS

## INTERSECTING CRACKS

## COMBINED PARALLEL AND INTERSECTING CRACKS

FIGURE 2. TYPICAL CRACK PATTERNS

Deflection measurements and a condition survey of the test pavement were made in the fall of 1974. Deflection readings were taken with the Dynaflect at 25 foot intervals over the study area. The condition survey was made noting the size and location of breakups, and the location and lineal feet of closely spaced parallel cracks, intersecting cracks, and combination cracks. Figure 2 shows the criteria used for determining the lineal feet of cracking. Lineal feet of cracking (L on Figure 2) was the longitudinal distance a specified type of crack was observed.

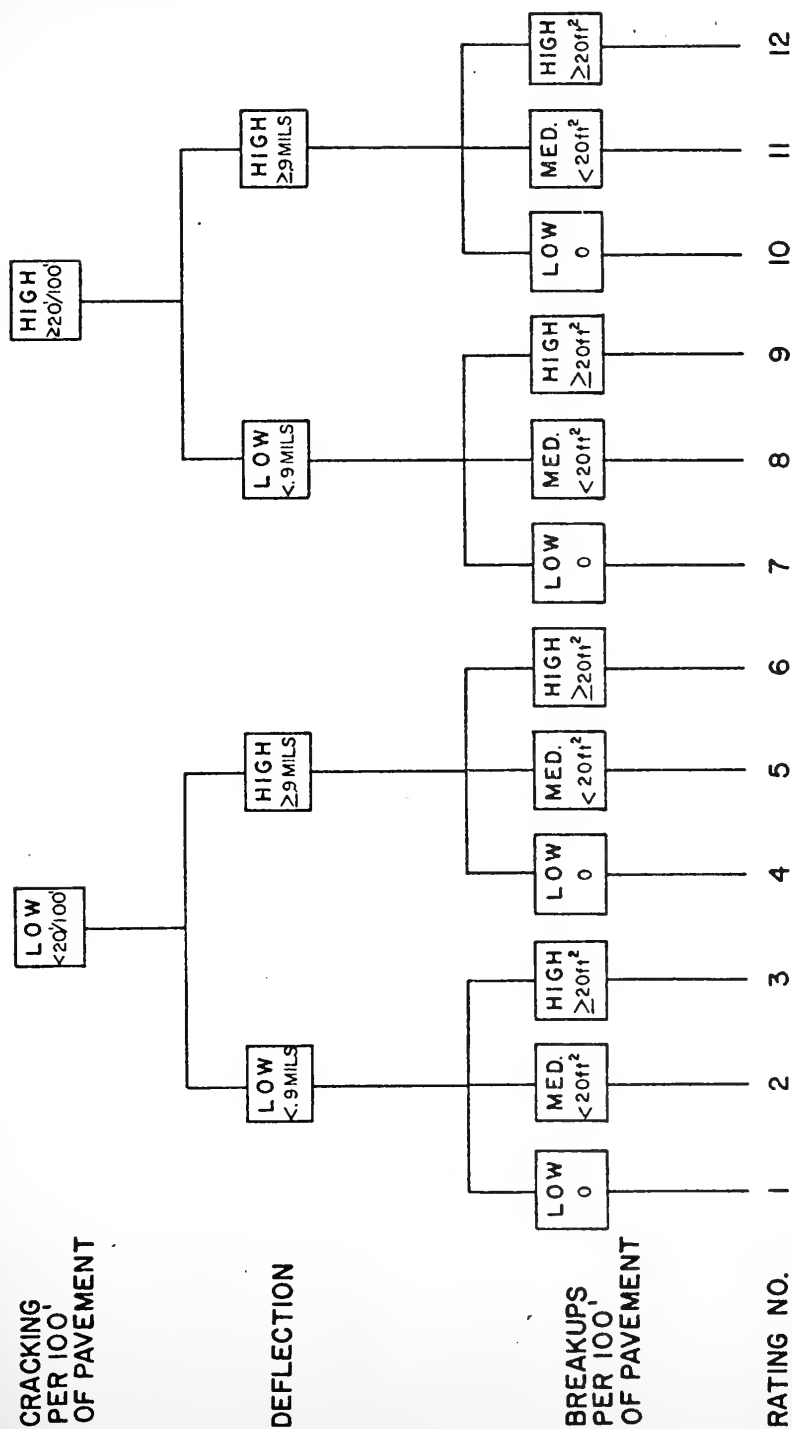
FIGURE 3. RATING OF TEST SECTIONS

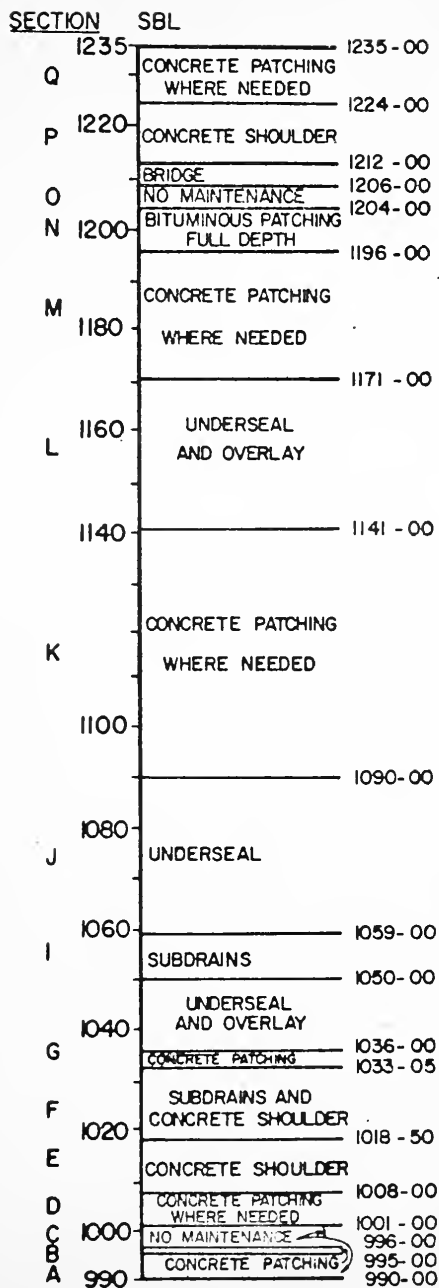
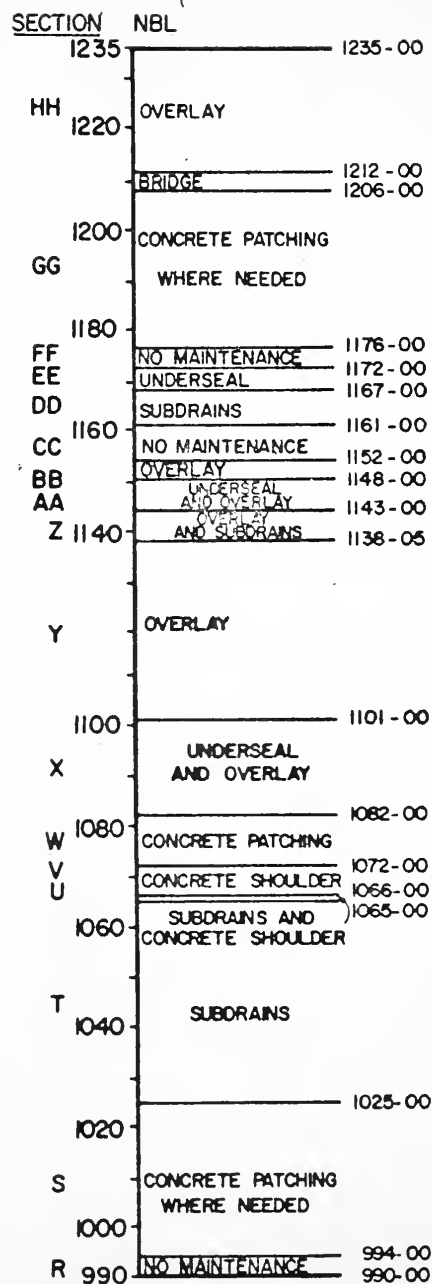
FIGURE 4. AS BUILT MAINTENANCE SECTIONS

NOTE: CONCRETE PATCHING SECTIONS WERE CONTROL SECTIONS FOR THE VARIOUS MAINTENANCE TYPES.

Referring to Figure 4 it is noted that several "no maintenance" sections were in the experiment. These were sections of pavement that were considered to be in good repair and they required no maintenance at all. Hence, they are excluded from all further analysis.

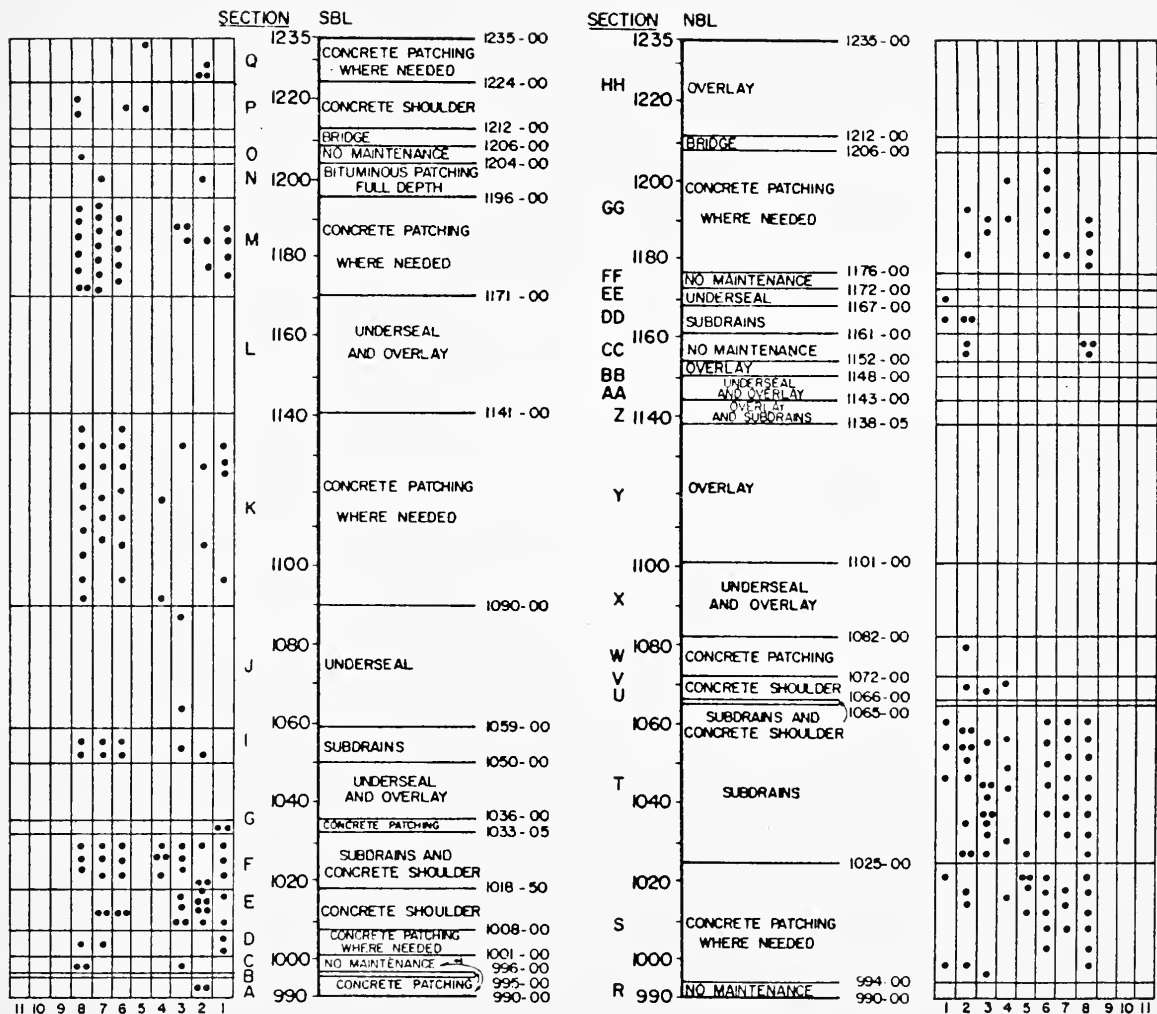
FIGURE 5. FAILURE AS A FUNCTION OF LOCATION AND TIME

NOTE: CONCRETE PATCHING WAS DONE WHERE NEEDED IN ALL AREAS EXCEPT NO MAINTENANCE AREAS.

Figure 5 shows the number of failures that have occurred on the test pavement during various time periods. Before the test pavements were constructed 102 failures had occurred over the entire section and 112 additional failures occurred two years after the test sections were constructed. It should be recalled that this test pavement is considered to be a severe test since it contained most of the features that have been known to contribute to poor performance of CRCP in the state of Indiana.

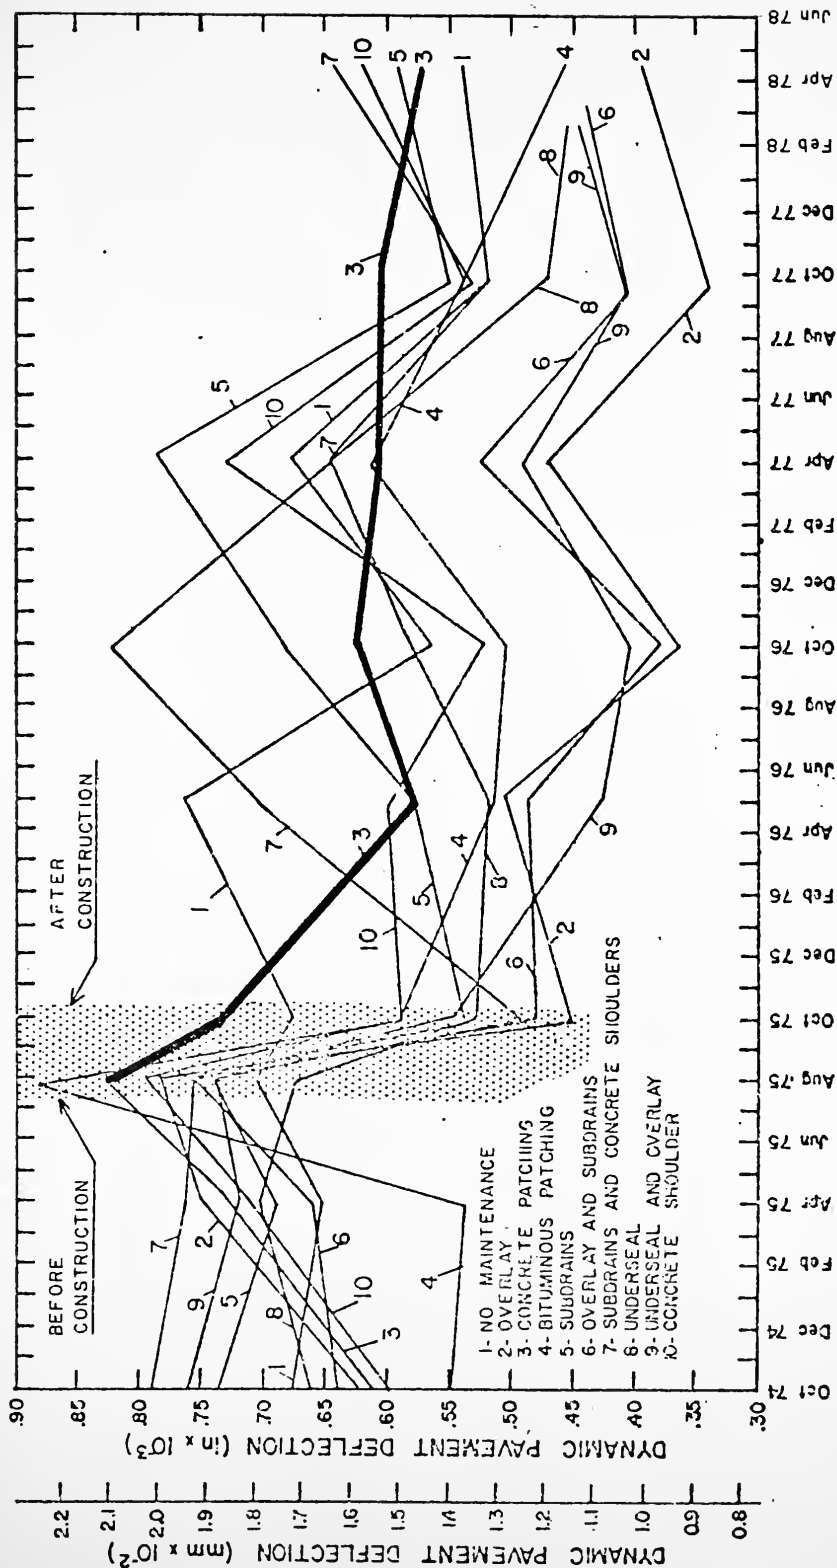
FIGURE 6. MEAN DEFLECTION VS. TIME

An Analysis of Variance was performed using the deflection data of the various treatments. Virkler (10) indicated that the analysis of variance was not conclusive in relating deflection with type of treatment. This was because the variability within the test sections was quite high and, therefore, the conclusions are based primarily upon the generalized relationships shown in Figure 6.

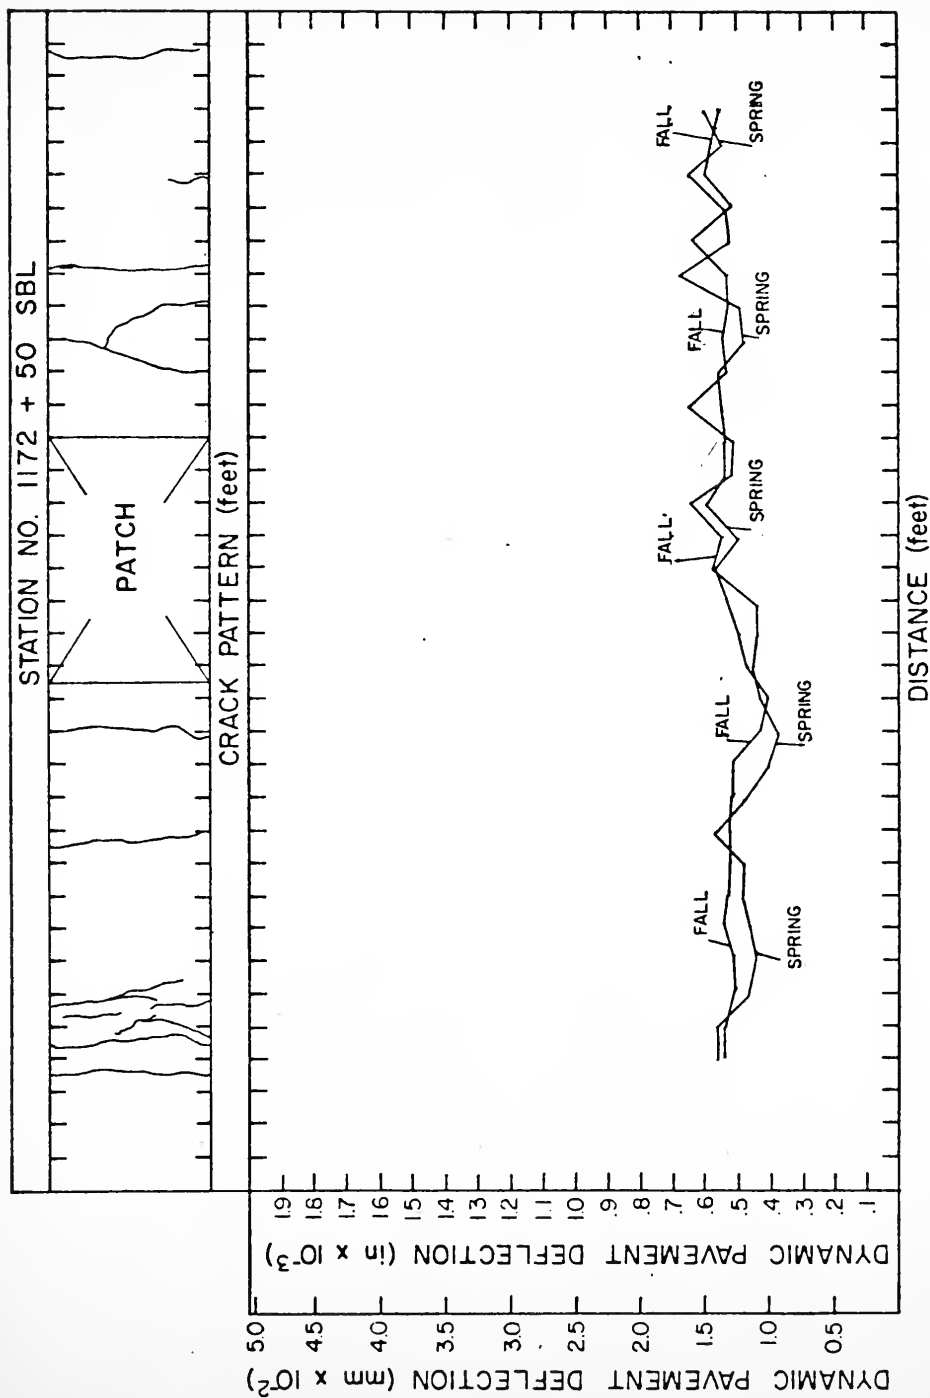
FIGURE 7. DEFLECTION IN VICINITY OF CONCRETE PATCH  
IN GOOD CONDITION

failures, 43 were failures at concrete patches and 1 was a failure adjacent to a bituminous patch. In an effort to assist in determining the extent of digout required for patching to preclude failures a series of measurements were made at 27 patches with the Dynaflect to determine if this instrument could be used to detect extent of weakening of the pavement (see Virkler, ref. 10). Figures 7 and 8 show two typical deflection patterns across patches, one in good condition and the other in poor condition.

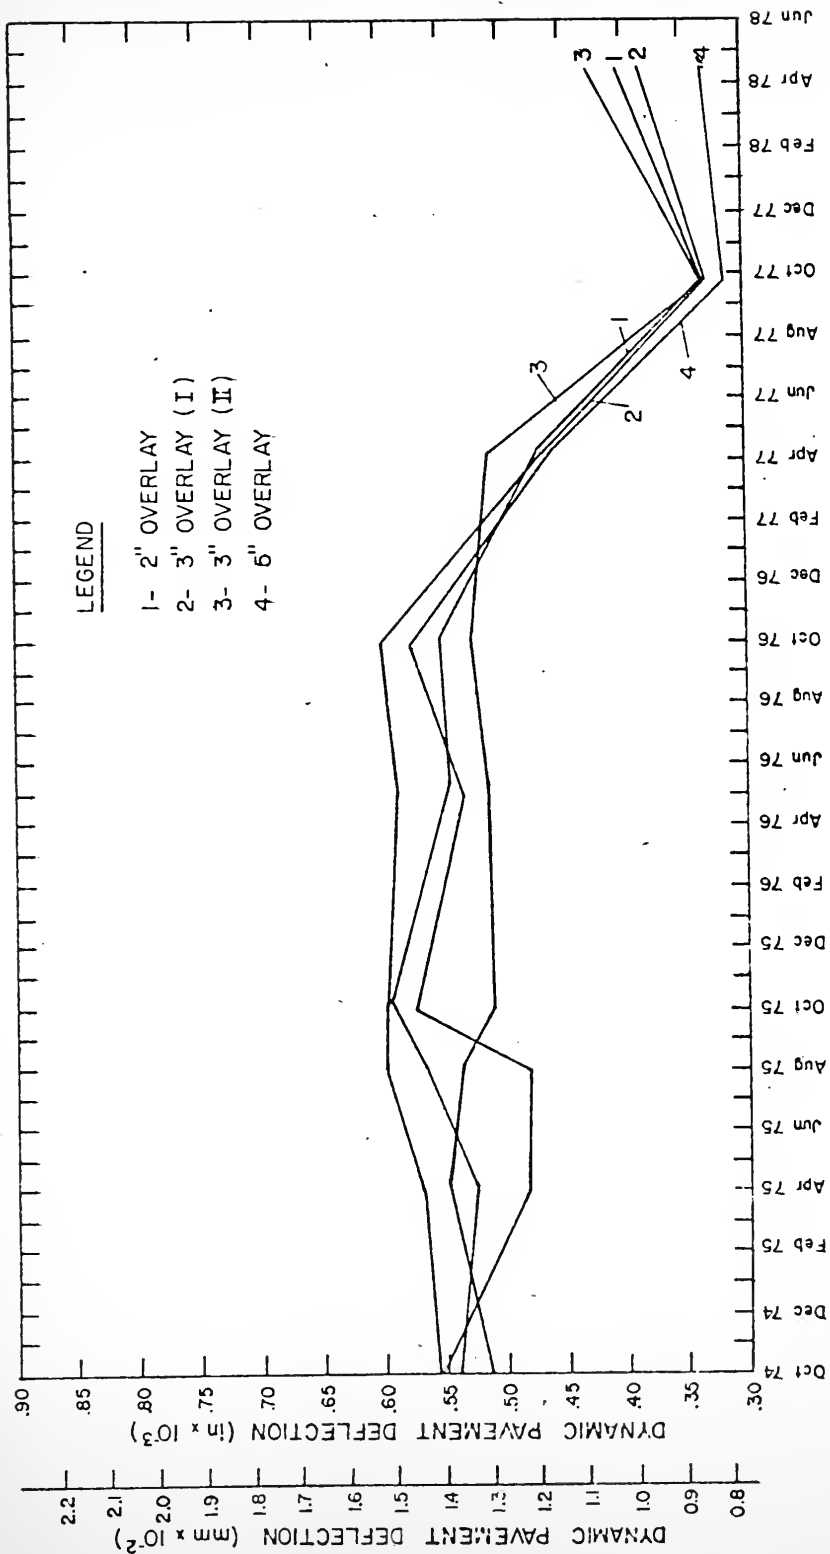
FIGURE 9. MEAN DEFLECTION vs. TIME -  
COMBINATION OF OVERLAY SECTIONS
